### **Project ID: BMP\_09**

## Severn River Sub-Watershed: BMP 09-Retrofit

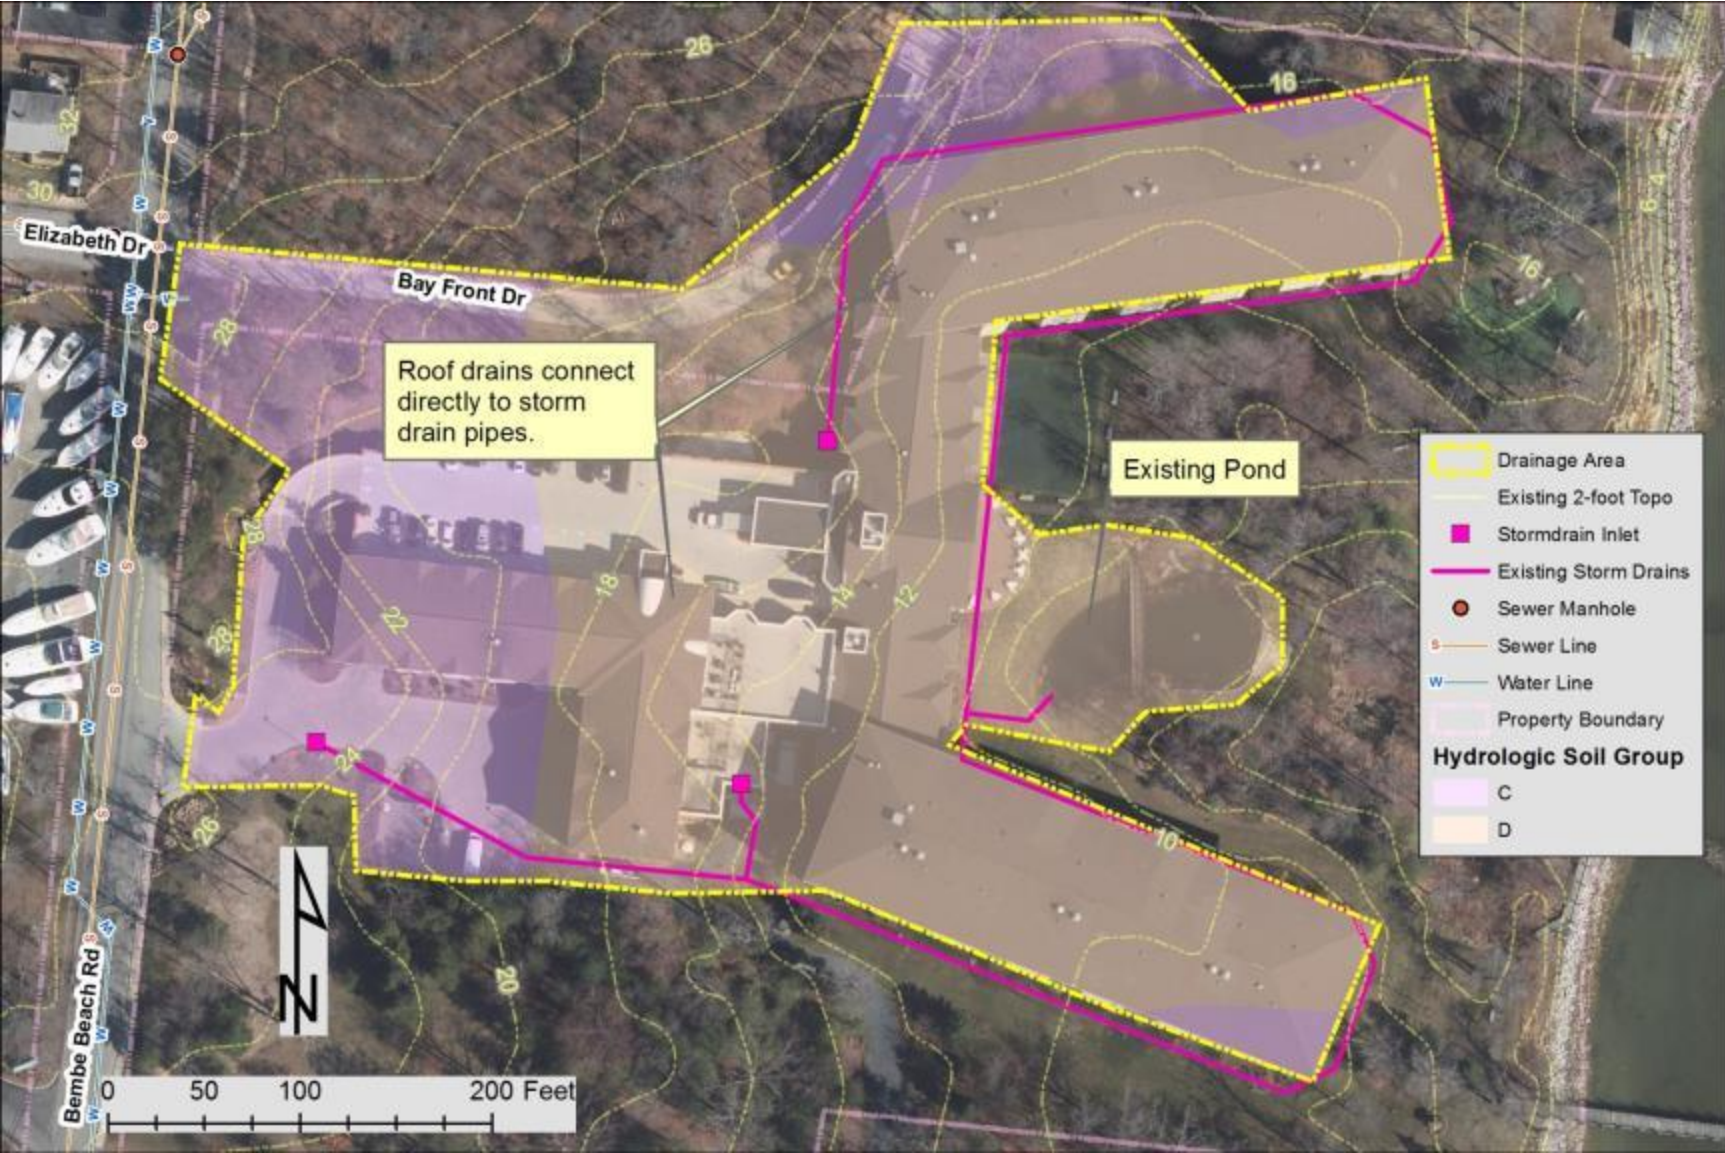
Figure 11: Existing Conditions and Drainage Area

The pond is located in the FEMA 100-year floodplain with a static base flood elevation of 5 feet North American Vertical Datum of 1988. The pond has an aerator and a fountain, although during field investigation water was brown and murky. There is ornamental vegetation around the pond and a footbridge crossing the pond. Neither sanitary sewer lines nor water lines were identified in the vicinity of the existing pond. The soils in the drainage area are hydrologic soil groups C and D, and the pond is located over hydrologic group D soils. The pond is located within the Limited Development Area (LDA); however, Anne Arundel County does not have additional requirements for stormwater management in the LDA. Figure 11 shows the existing conditions map with drainage area.

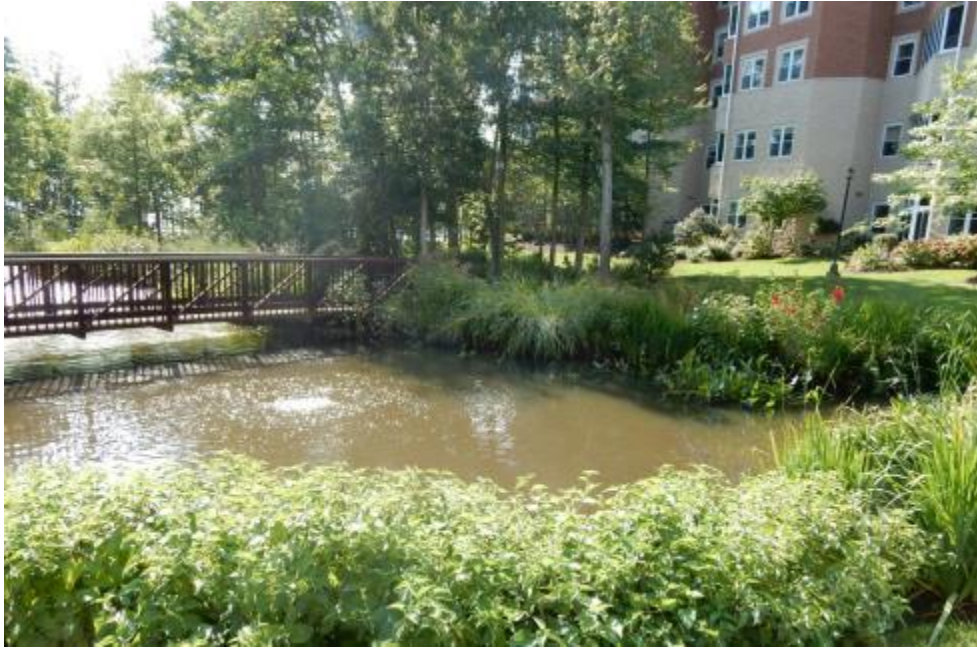
**Existing Pond at BayWoods of Annapolis (facing east)**

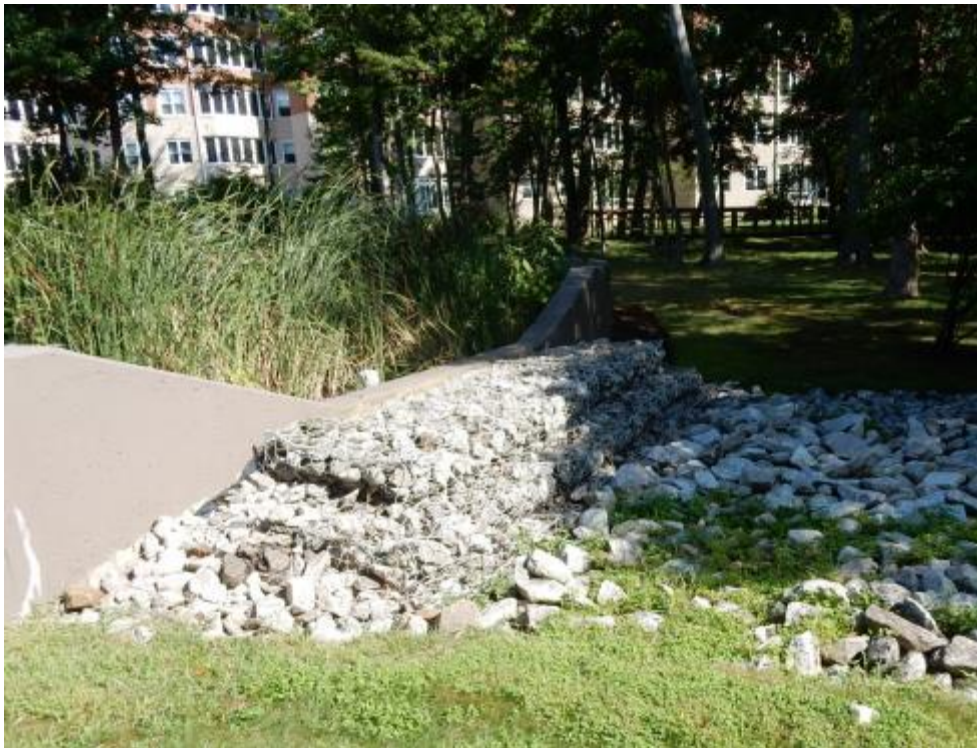
**Existing Pond at BayWoods of Annapolis Overflow Weir and Outfall Protection (facing northwest)**

MDE standards. The existing perforated standpipe may need to be replaced, although no changes to the overflow weir are proposed.
